# ***BAY MILLS INDIAN COMMUNITY SUMMARY OF CLEANUPS***

- Silverdome**
- Bay Mart Gas Station & C-Store**
- Superior Township Dump**

# ***SILVERDOME (FORMER MAINTENANCE YARD)***

# ***BAY MART GAS STATION & C-STORE***

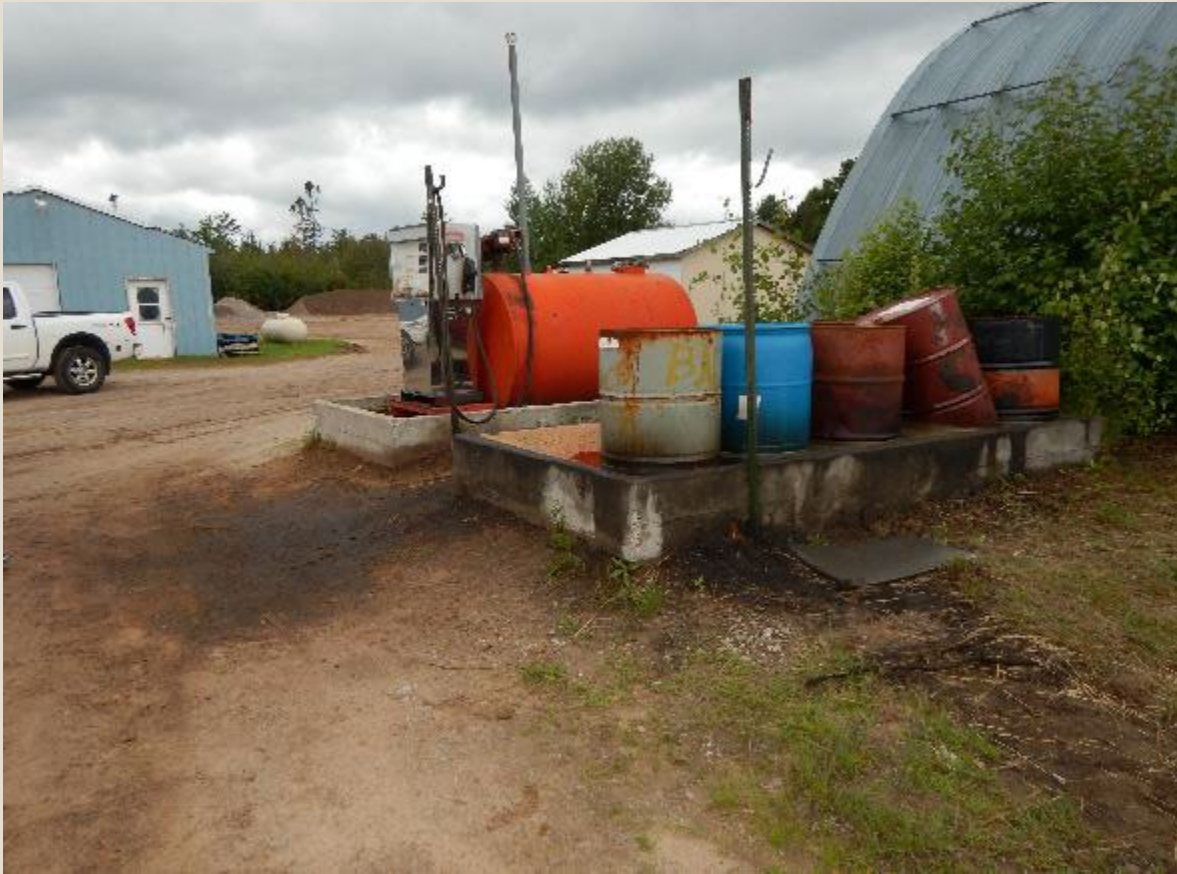
1. One aboveground storage tank over secondary containment.
2. Secondary Containment with seven, distressed/leaking 55-gallon drums; two 30-gallon containers and two five-gallon pails.

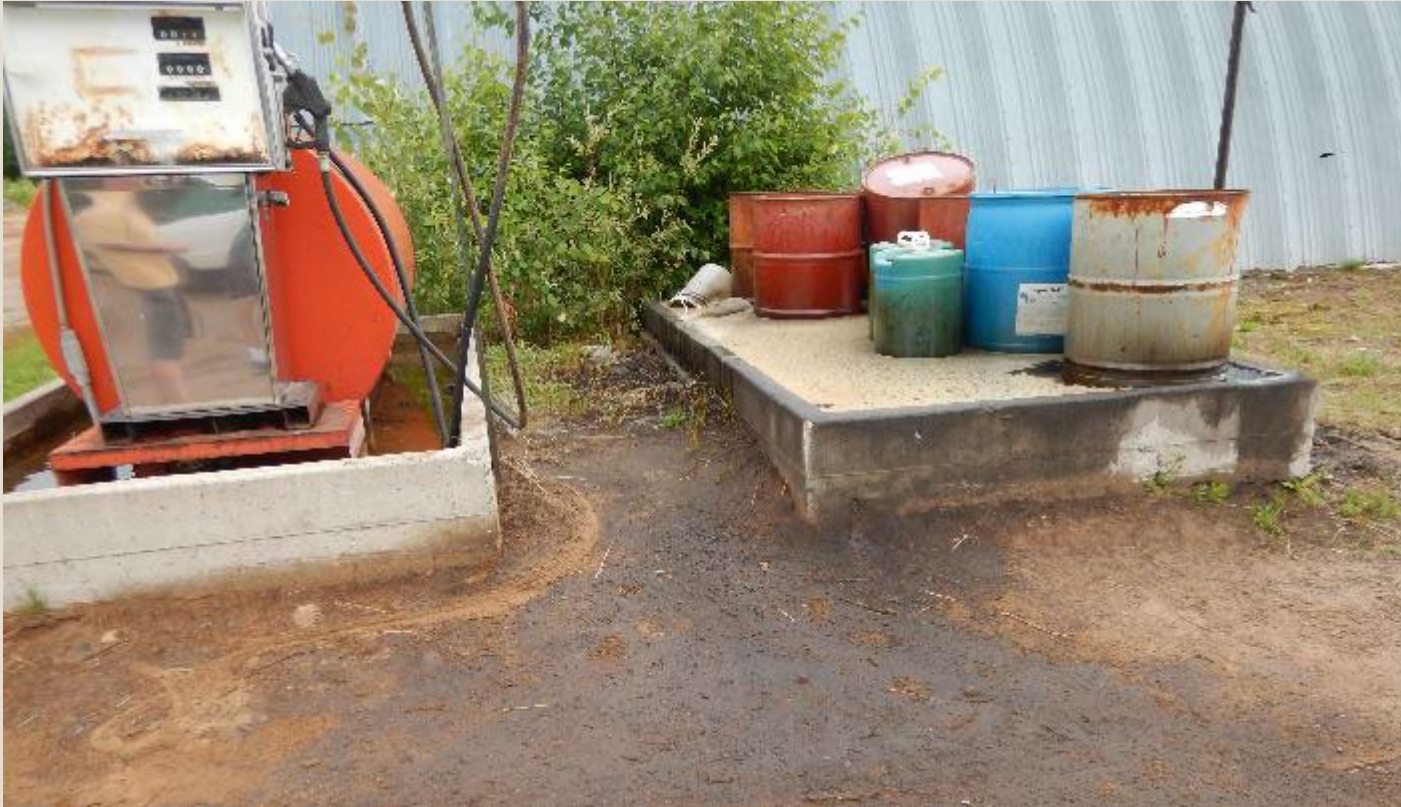
Liquid displacement inside the secondary containment from rain - discharge of liquids outside the secondary containment structures.

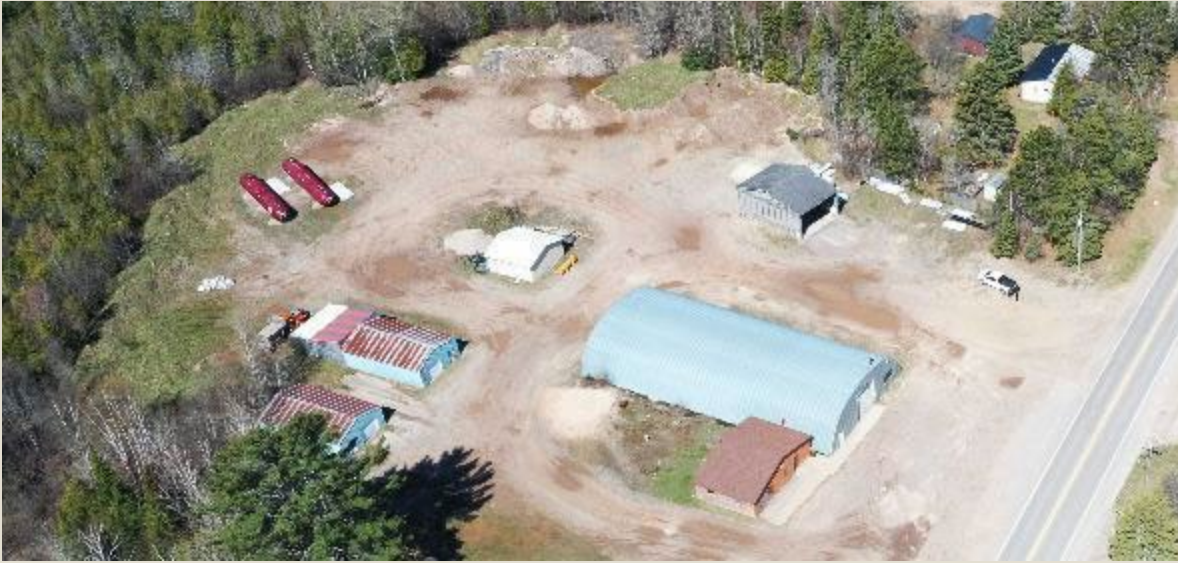
Numerous abandoned 55-gallon drums in the surrounding area.

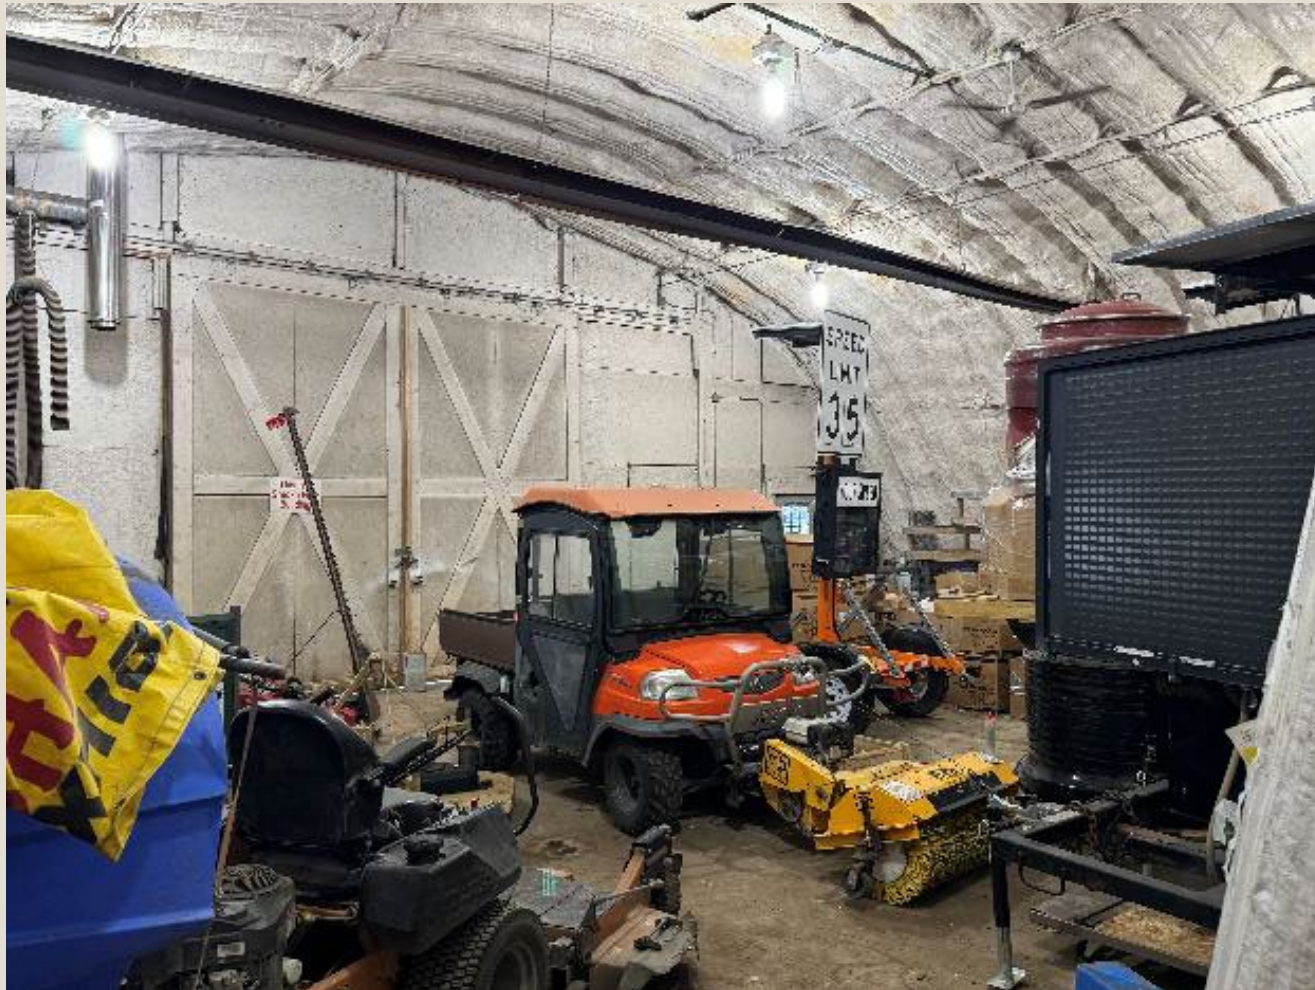
- Historical vehicle repair.
- The source or spill event for the Tetrachloroethylene<sub>15</sub> has not been determined.

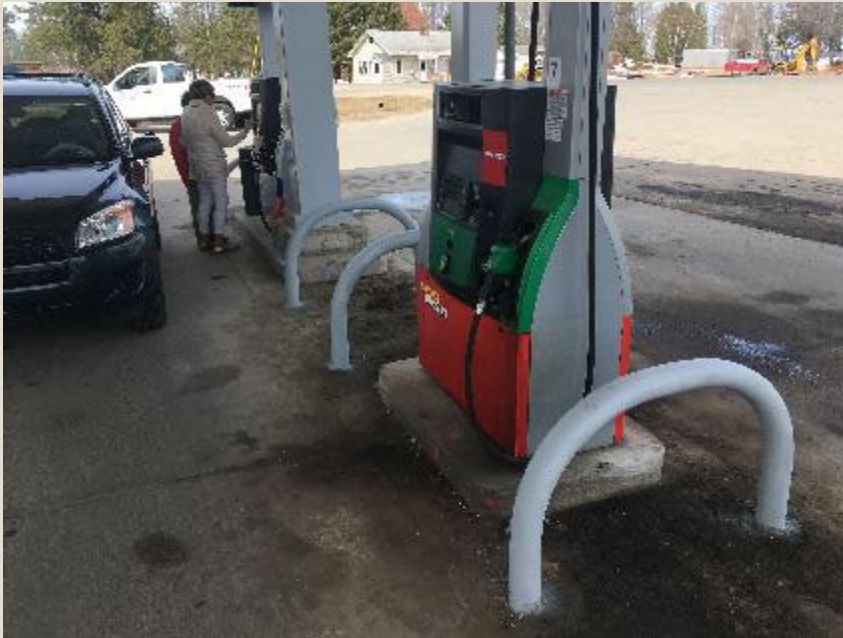
- March 2018: A site assessment was conducted following modifications to the product supply lines.
- Contaminated soil (elevated lab data) was encountered adjacent to the diesel fuel dispenser.
- Confirmed Release #2: (C-0029-18) was reported on March 8, 2018.

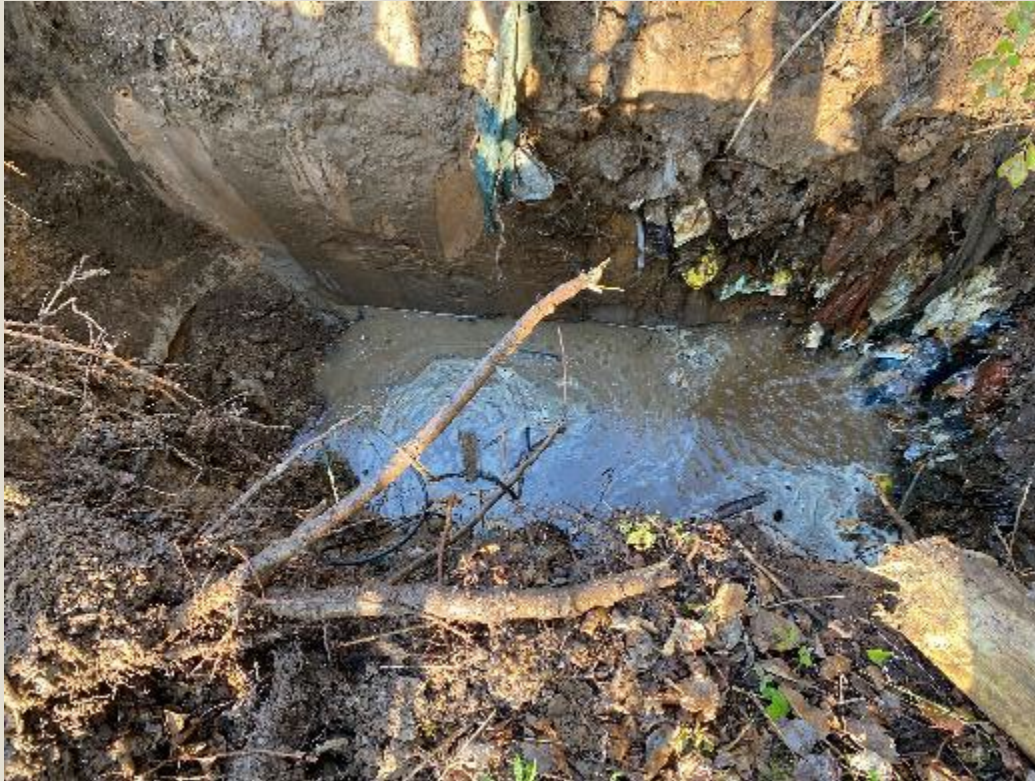
- ❑ Test Pit #2: Middle of clearing – At the north edge.
- ❑ Surface to 6': Solid Waste (plastics, glass, tires & metal debris); 6' to 8': Clay
- ❑ Perched groundwater is running into the excavation.

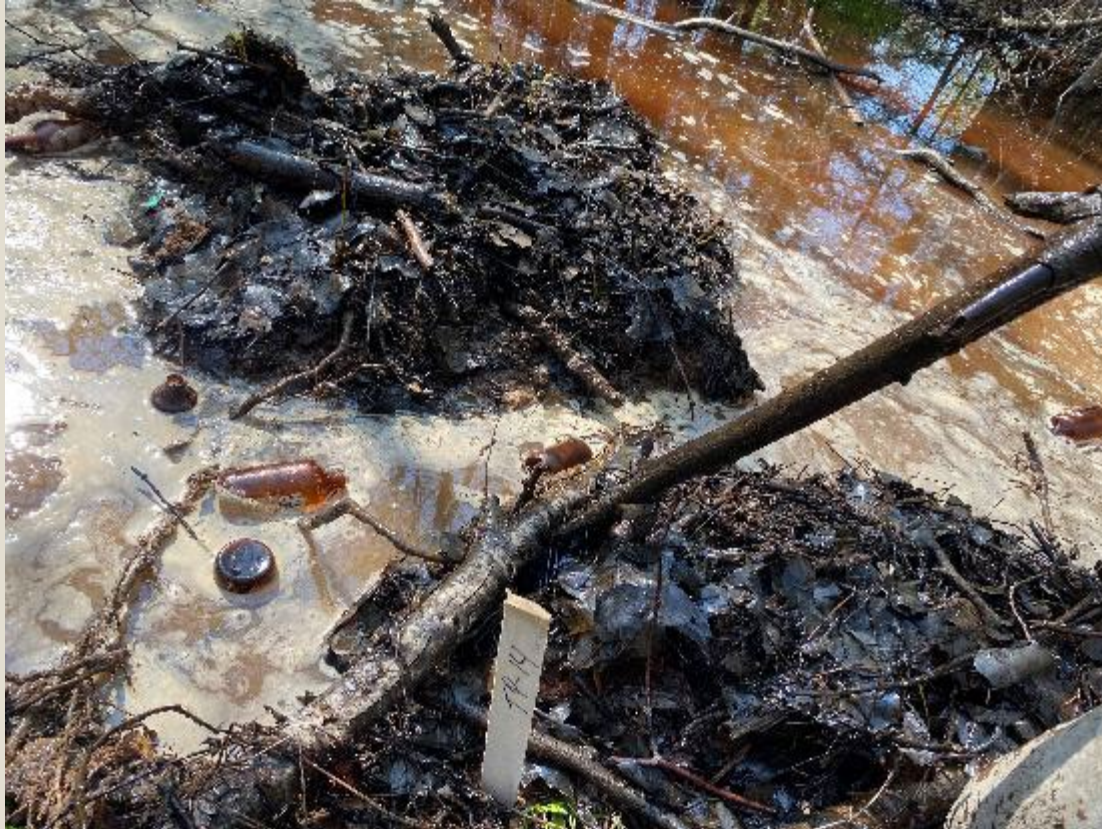
- ❑ Test Pit #14: South of the access road
- ❑ Surface to ?: Solid Waste (plastics, glass & metal debris).
- ❑ Perched groundwater is running into the excavation.

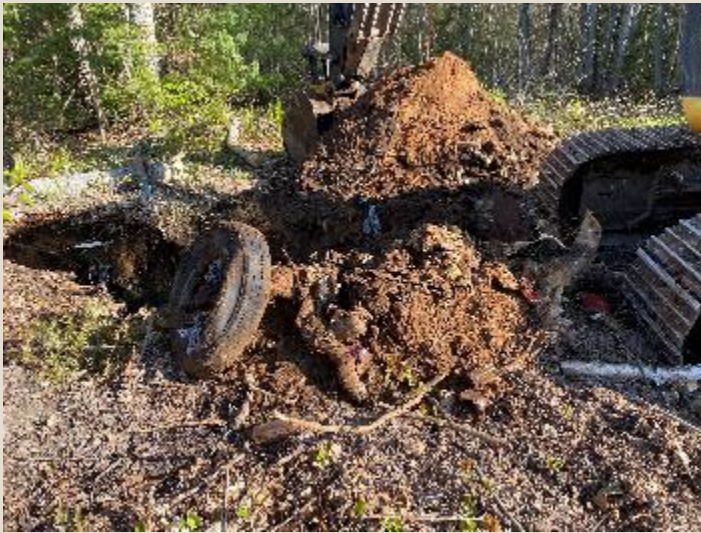
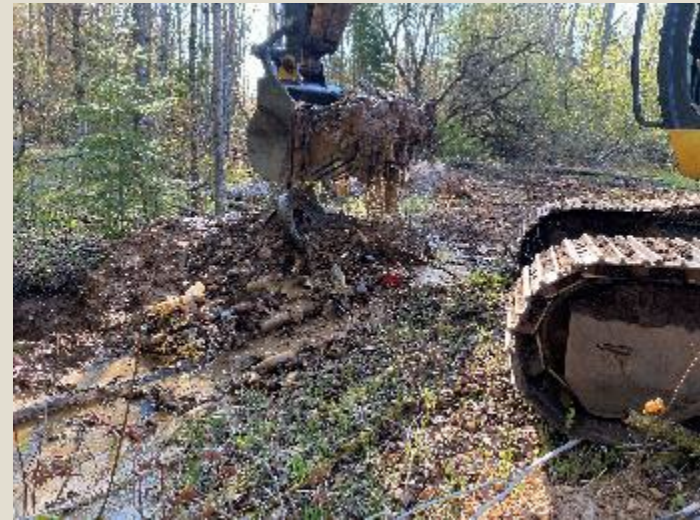
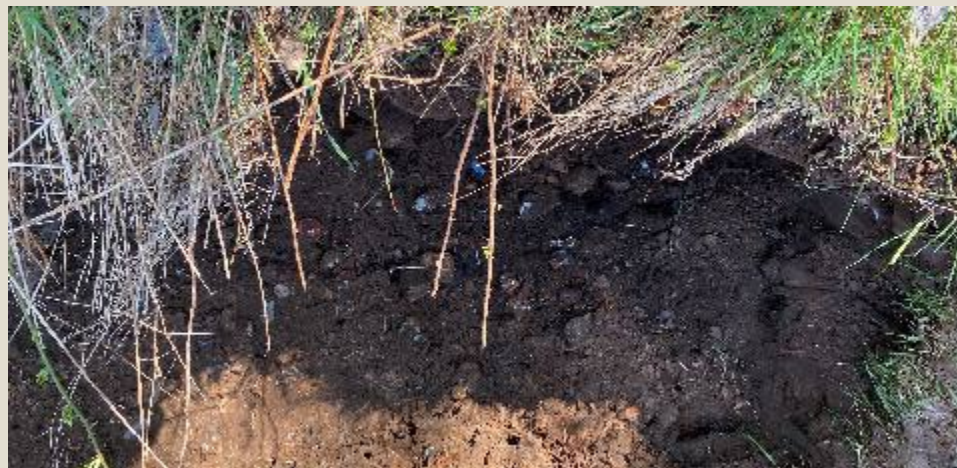
**Area A:** This area represents the Main Dump. It is characterized by surface debris and buried debris/garbage.

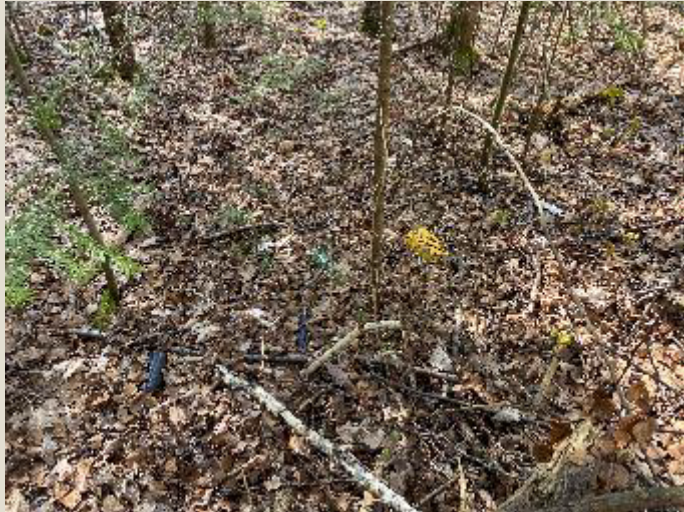
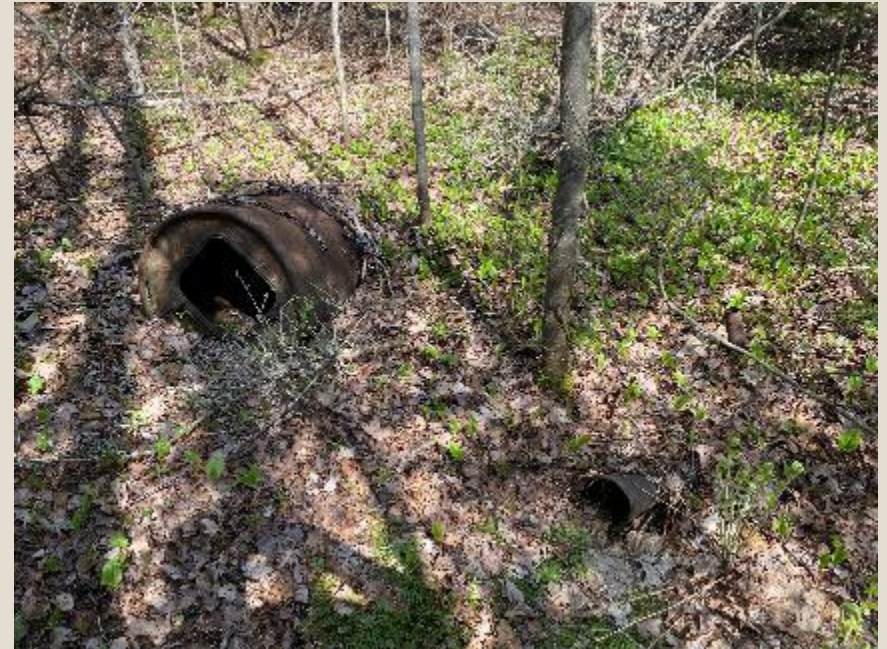
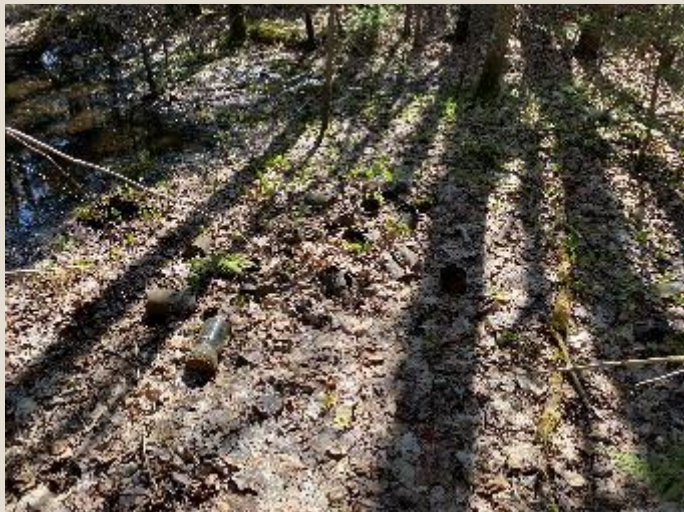
**Area B:** This area is located west and east along the main dump access road. It is characterized by scattered surface debris located throughout.

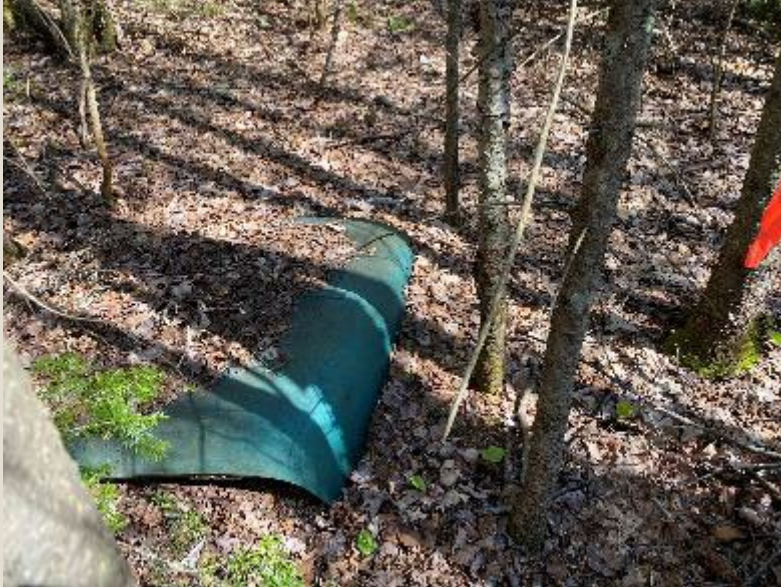
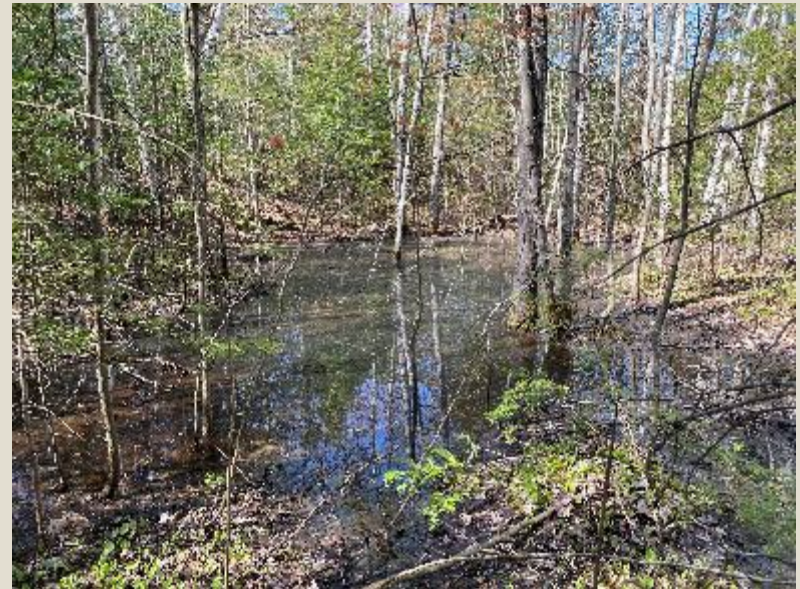
**Area C:** This area is located east and west of Area A. It is characterized by discrete, scattered surface debris.

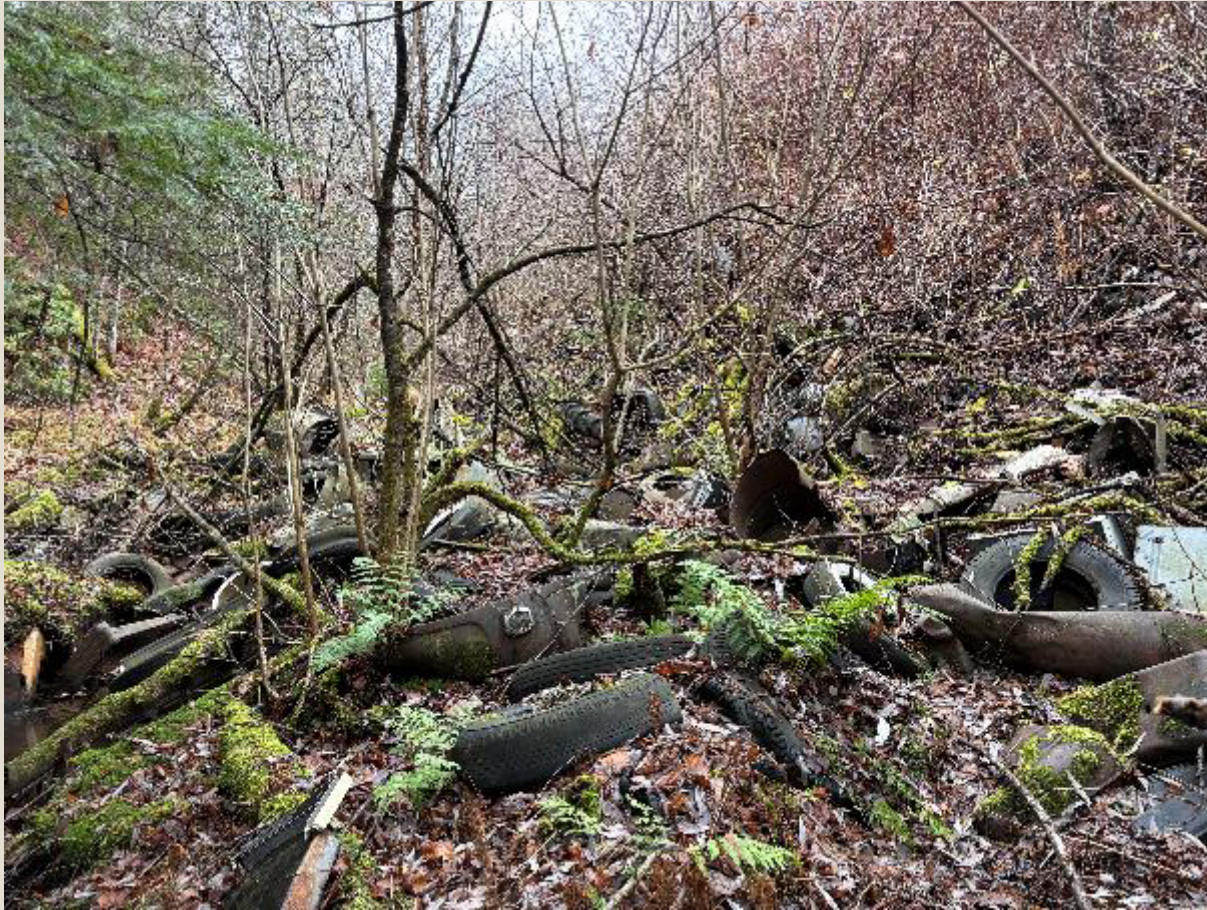
Looking east along the creek. The solid waste is is located on the creek and along both banks.
